CHAPTER 4: THE FULTON MALL

4.2 HISTORY OF THE FULTON MALL

4.3 EXISTING CONDITIONS

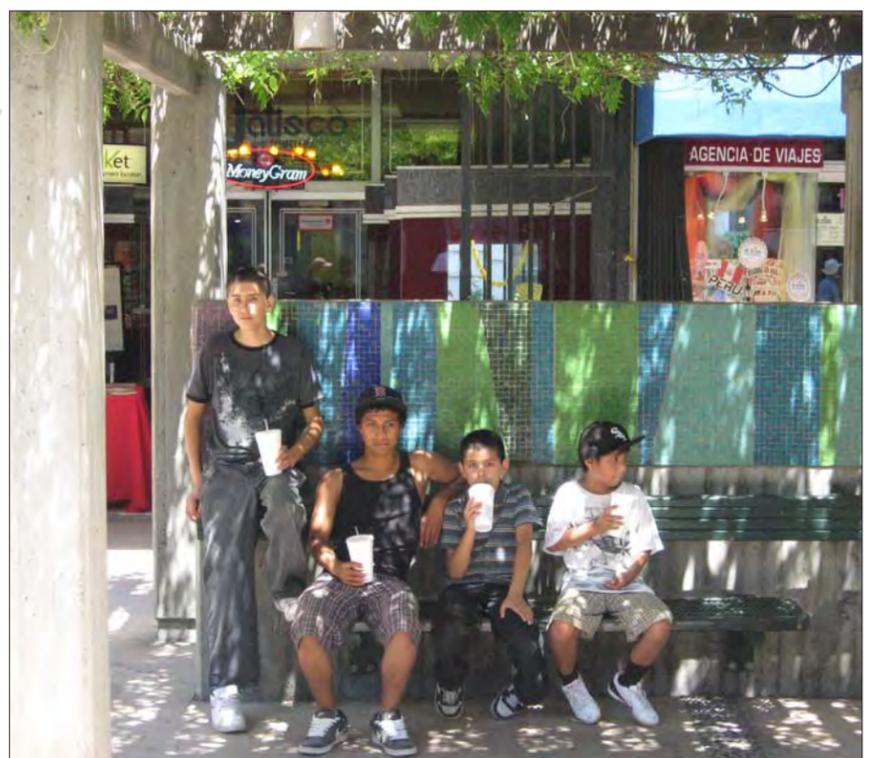
Fulton Mall patrons sit beneath one of the trellis structures. One of several mosaic installations is seen behind the bench.

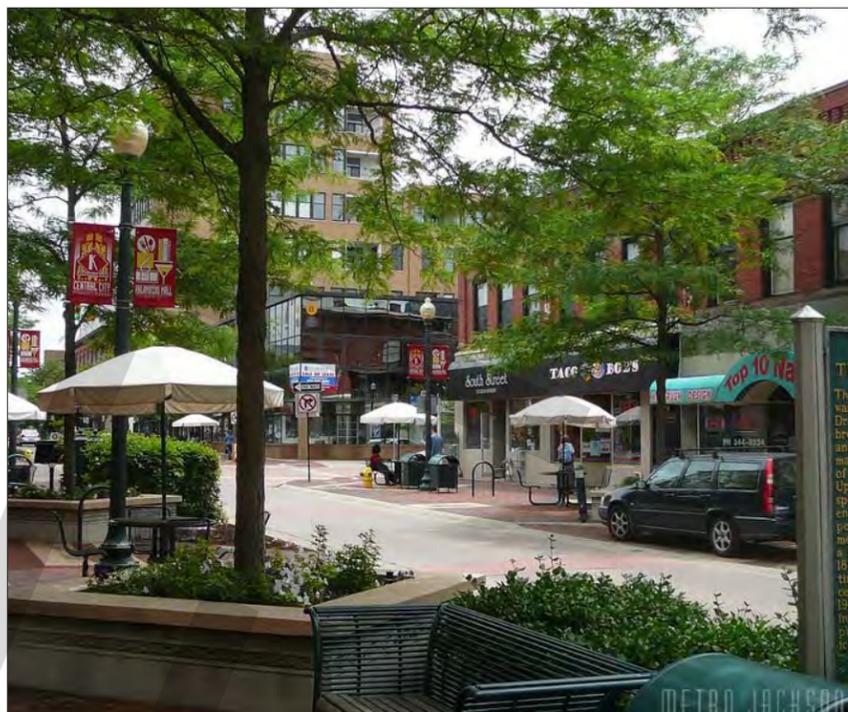
Two of the original four blocks of the Kalamazoo pedestrian mall have been reopened to automobiles since the malls construction in 1959.

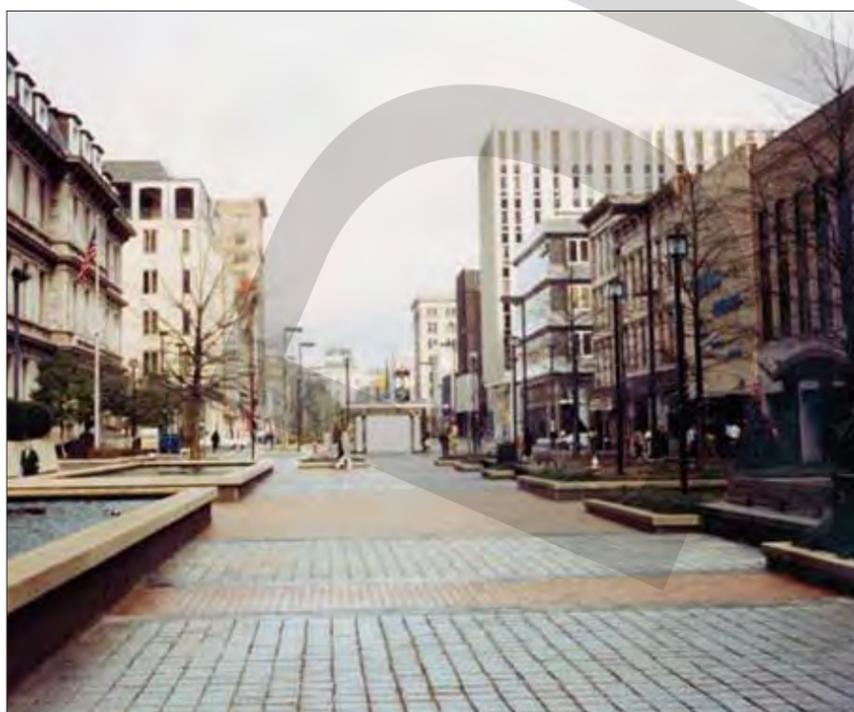
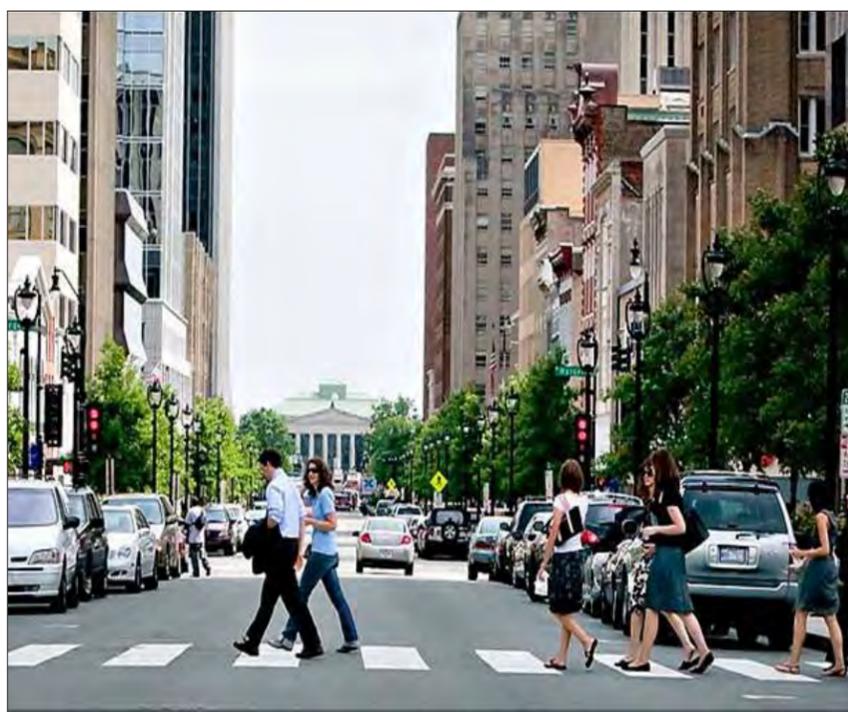
The economy rebounded quickly along Fayetteville Street in Raleigh, NC (above right), when the street was reopened in 2006 after 30 years as a closed pedestrian mall (above left). The reopening of the four blocks cost \$9.3 million. “With the reopening of the street, our city can come back home to Fayetteville Street,” Raleigh Mayor Charles Meeker told the crowd of some 35,000 at the reopening celebration. For several years the city celebrated the reopening with an annual festival.

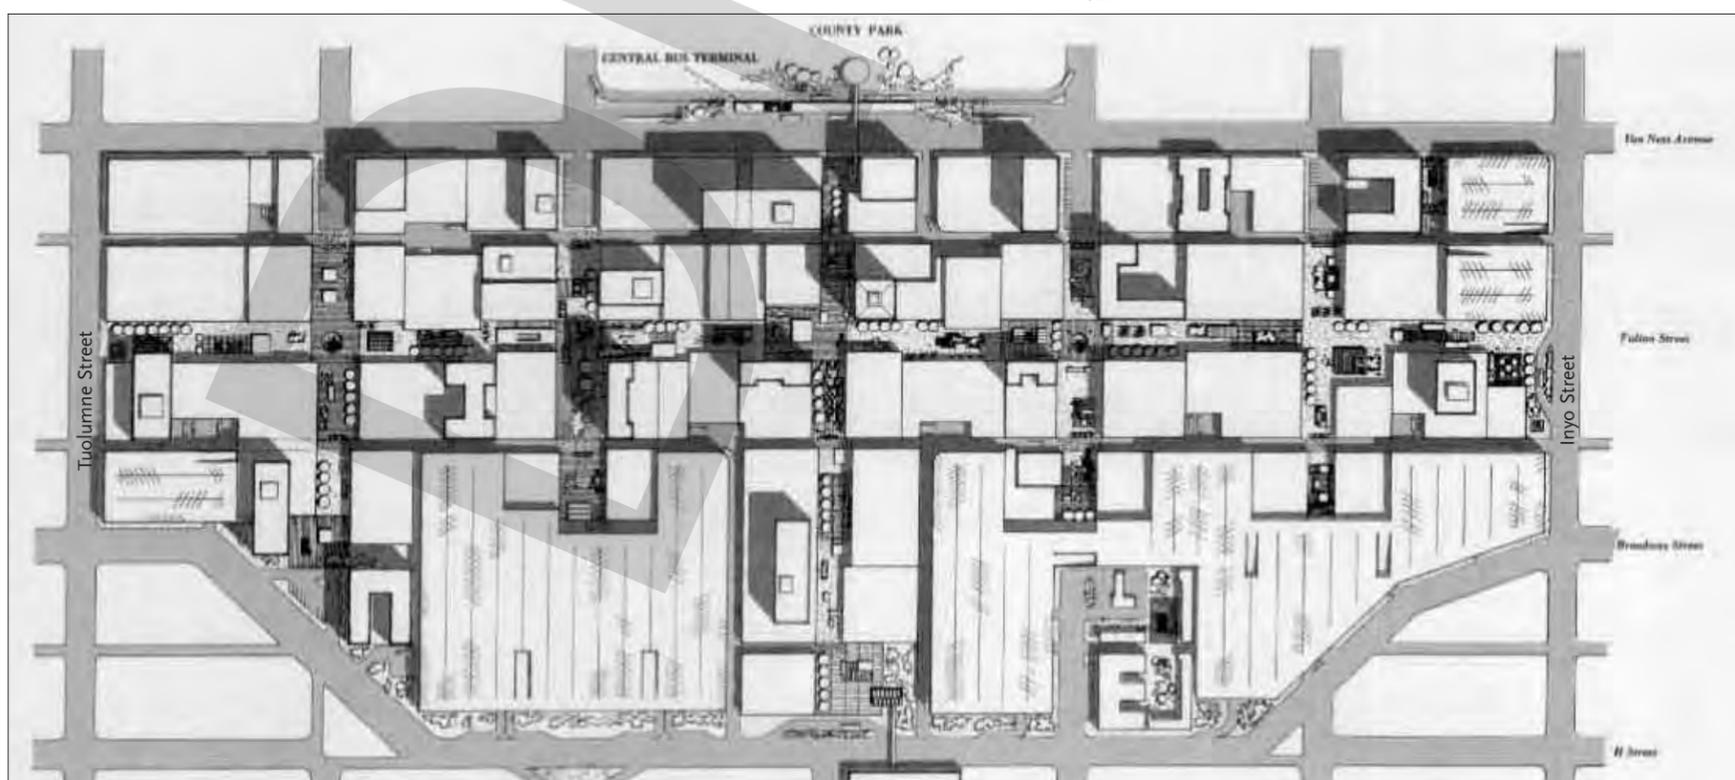
Victor Gruen's Plan for Fulton Street and surrounding blocks.

In the mid 1950's, Downtown Fresno merchants and elected officials sought to address Downtown's decline with a bold new plan to remake the Fulton Corridor. They hired famed shopping mall architect Victor Gruen to develop a long term plan to rebuild the core of the City. The plan included a recasting of the Downtown according to modernist planning principles, and its centerpiece was an 80 acre pedestrian-only "superblock" surrounded by a one way street loop (see below). Pedestrians and cars were separated from each other and so were all uses. While the Plan was never fully realized, its centerpiece, the Fulton Mall, designed by the prominent landscape architect Garrett Eckbo, opened in 1964 to national acclaim and initial commercial success. It was the nation's second downtown Pedestrian Mall, and helped spur a wave of similar projects in other American cities throughout the 1960's and 1970's.
